North Fork Dam. (NDS ID Number 234).
Ohio River Basin, North Fork Bens Creek,
Somerset County, Pennsylvania.

PHASE I REPORT
NATIONAL DAM INSPECTION PROGRAM

NAME OF DAM: North Fork Dam
STATE LOCATED: Pennsylvania
COUNTY LOCATED: Somerset
STREAM: North Fork of Bens Creek, tertiary tributary of Conemaugh River
DATE OF INSPECTION: April 24 and 25 and May 4, 1978

NORTH FORK DAM
NDS I.D. NO. 234
APRIL 24 AND 25, 1978

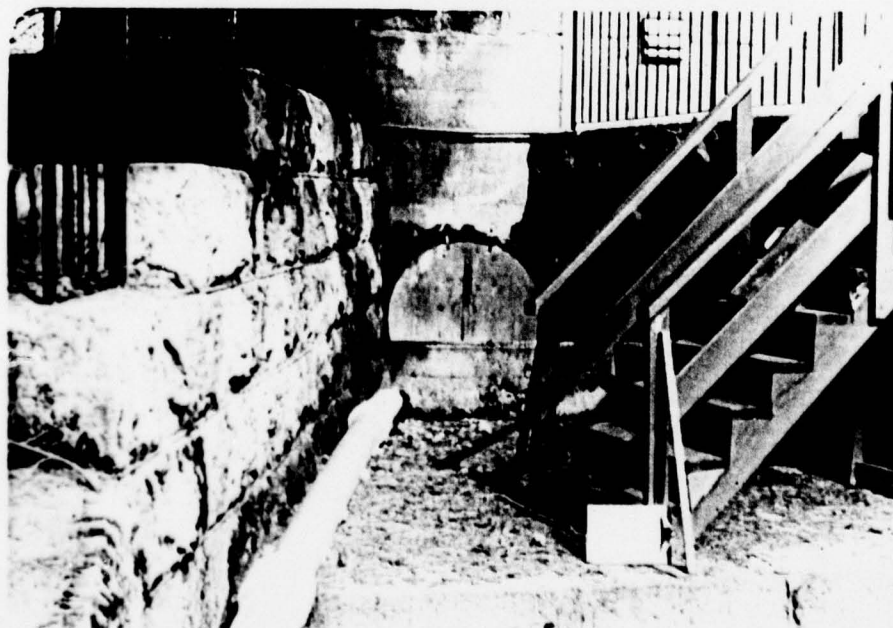
4.3 Maintenance of Operating Facilities. The blow-off pipe was operated by water company personnel and was observed to be functional.

Photograph No. 8

Outlet end of "blow-off" pipe.

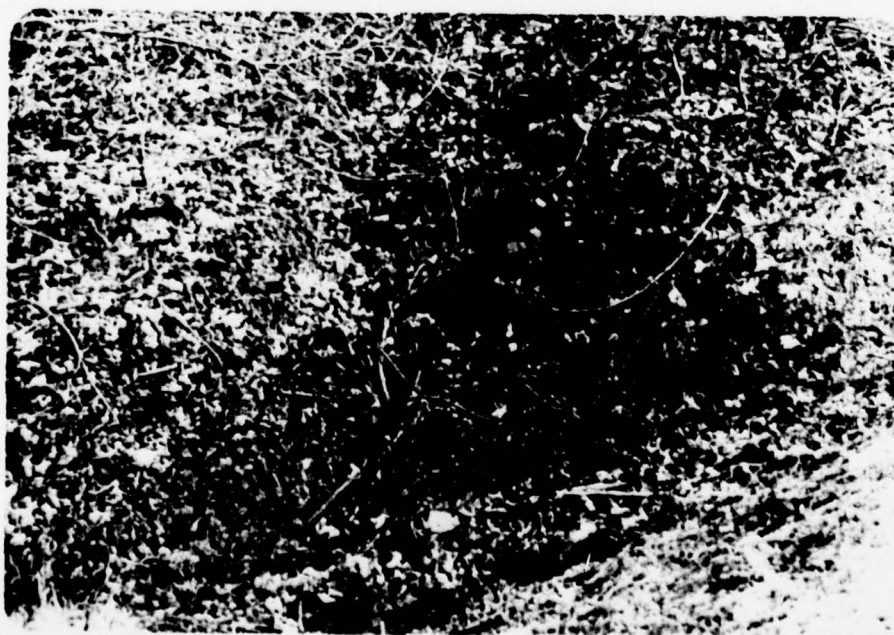
Only one seepage area was observed (Photograph 10). This was located on the right abutment, approximately at the elevation of the lower paved interceptor ditch on the downstream slope. The flow was estimated to be approximately 0.5 cfs. The effect of this seepage on the overall performance of the dam is considered to be inconsequential, but it should continue to be monitored to assure that it is not increasing.

3.2 Evaluation. In general, the condition of the dam is considered to be very good. A review of previous inspection reports revealed that during the period from 1933 to 1941 some seepage was reported along the right toe and on the abutment approximately 10 feet above the lower berm elevation. Two recent state inspections in 1966 and 1976 note no such seepage. On this inspection, minor seepage was observed on the right abutment (Plate 5).

Photograph No. 10
Minor seepage on south abutment (see Plate 3).
